Investigation of Multi-Wire Interconnected Lightweight PV modules Using Micro-Computed Tomography

Bin Luo, Rik Van Dyck, Jonathan Govaerts, Tom Borgers, Bart Ruttens, Jan D'Haen, Hariharsudan Sivaramakrishnan Radhakrishnan, Michael Daenen, Aart Willem Van Vuure, Jef Poortmans

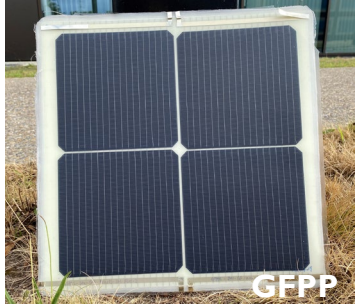
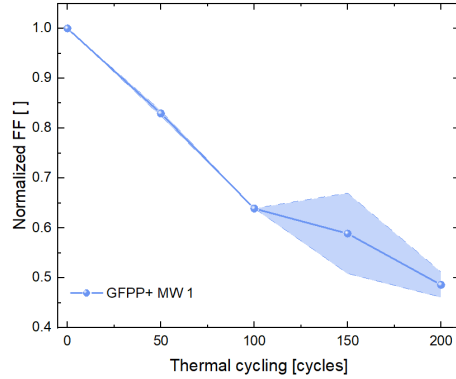
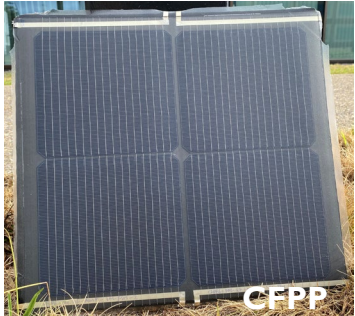
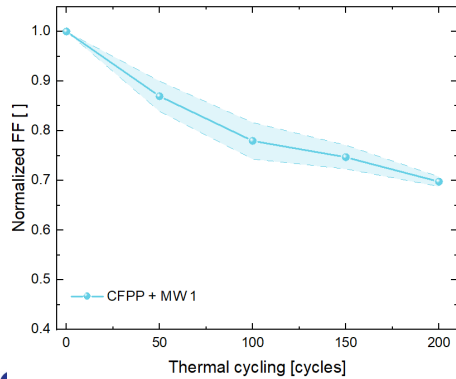
Thermal cycling (-40 to 85 °C, IEC 61215)

Before TC

After TC 200

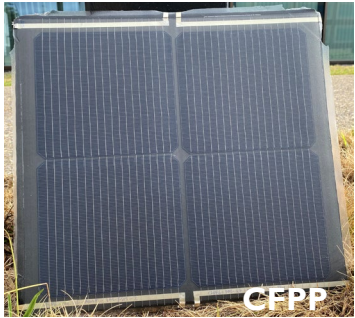
Thermal cycling (-40 to 85 °C, IEC 61215)

Before TC

After TC 200

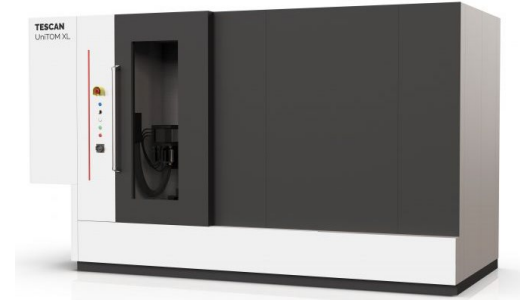
Tescan Unitom XL

3D Micro-computed tomography

- Non-destructive analyzing technique
- Multiple X-ray scans of rotating sample, followed by reconstruction to create 3D volume rendering
- Voxel (3D Pixel) sized as low as 1-3 μm
- Resolution depends on sample size

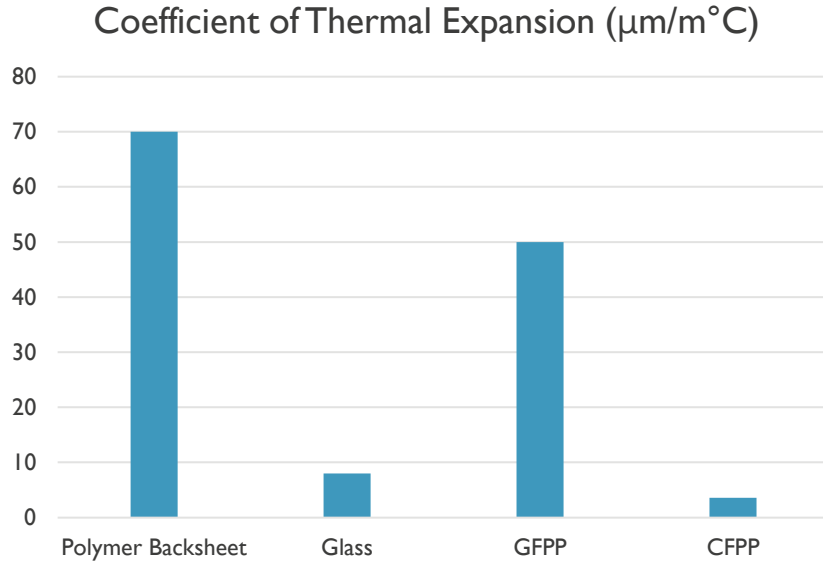
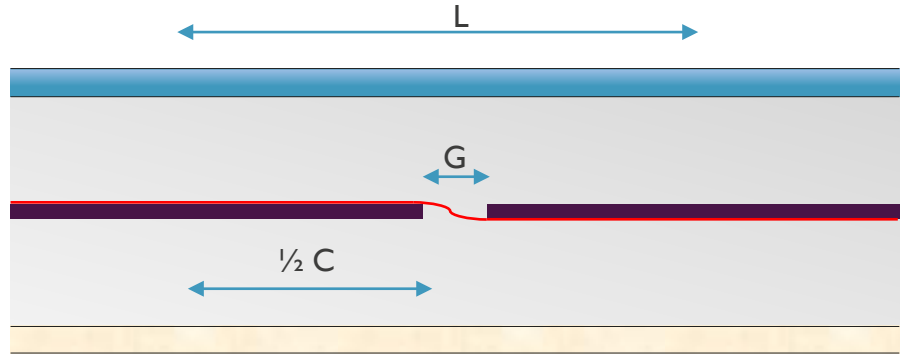
Reduced thermal strain

$$\Delta G = L \cdot \alpha_{backsheet} - C \cdot \alpha_{Si}$$

$$\text{GFPP: } \Delta G = 7.5 \mu\text{m}/^\circ\text{C}$$

$$\text{CFPP: } \Delta G = 0.2 \mu\text{m}/^\circ\text{C}$$

- Lightweight modules using a multi-wire interconnection are prone to degradation due to thermo-mechanical stress
- Decreasing the backsheet CTE improves the reliability
- 3D micro-computed tomography can be used to visually inspect interconnections
- Further investigation using FEM is ongoing
